# Characterization of Miller Run and Conceptual Plan for Watershed Restoration

Final Report for a Class Research Project

UNIV 298/GEOL 298/BIOL 298/ENST 298  
Stream Restoration -- Spring 2009

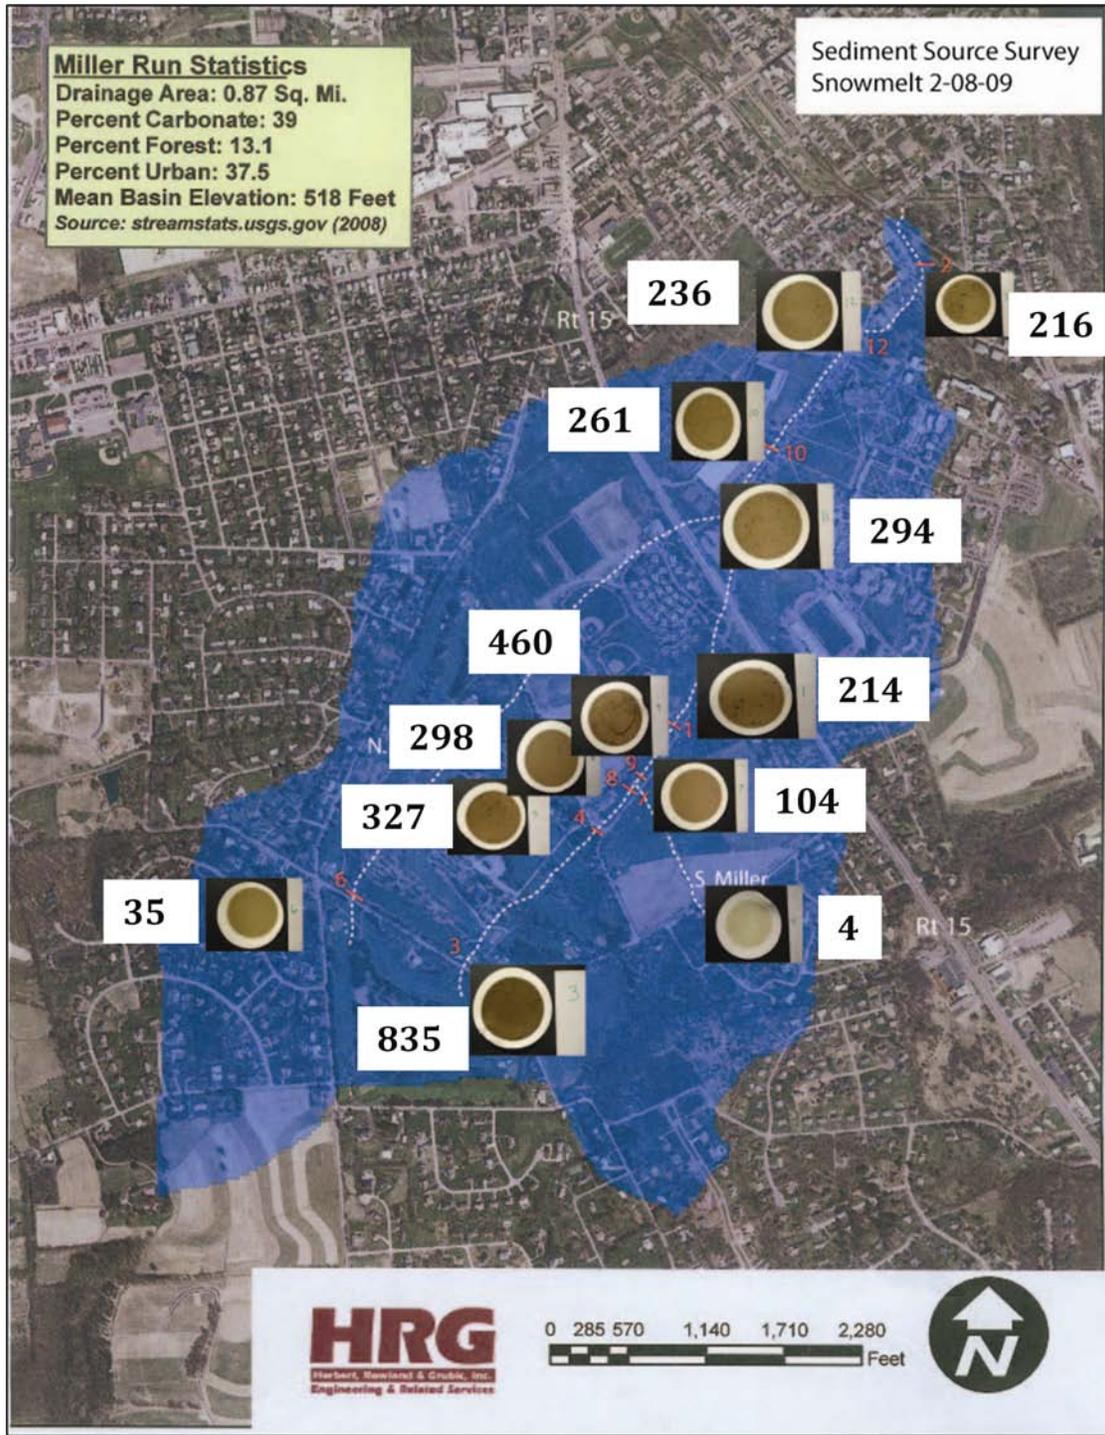
**Figure 2-18.** Sediment Contributions from Various Tributaries from the February 8-9, 2009 snowmelt event. Numbers show sediment concentrations in ppm.

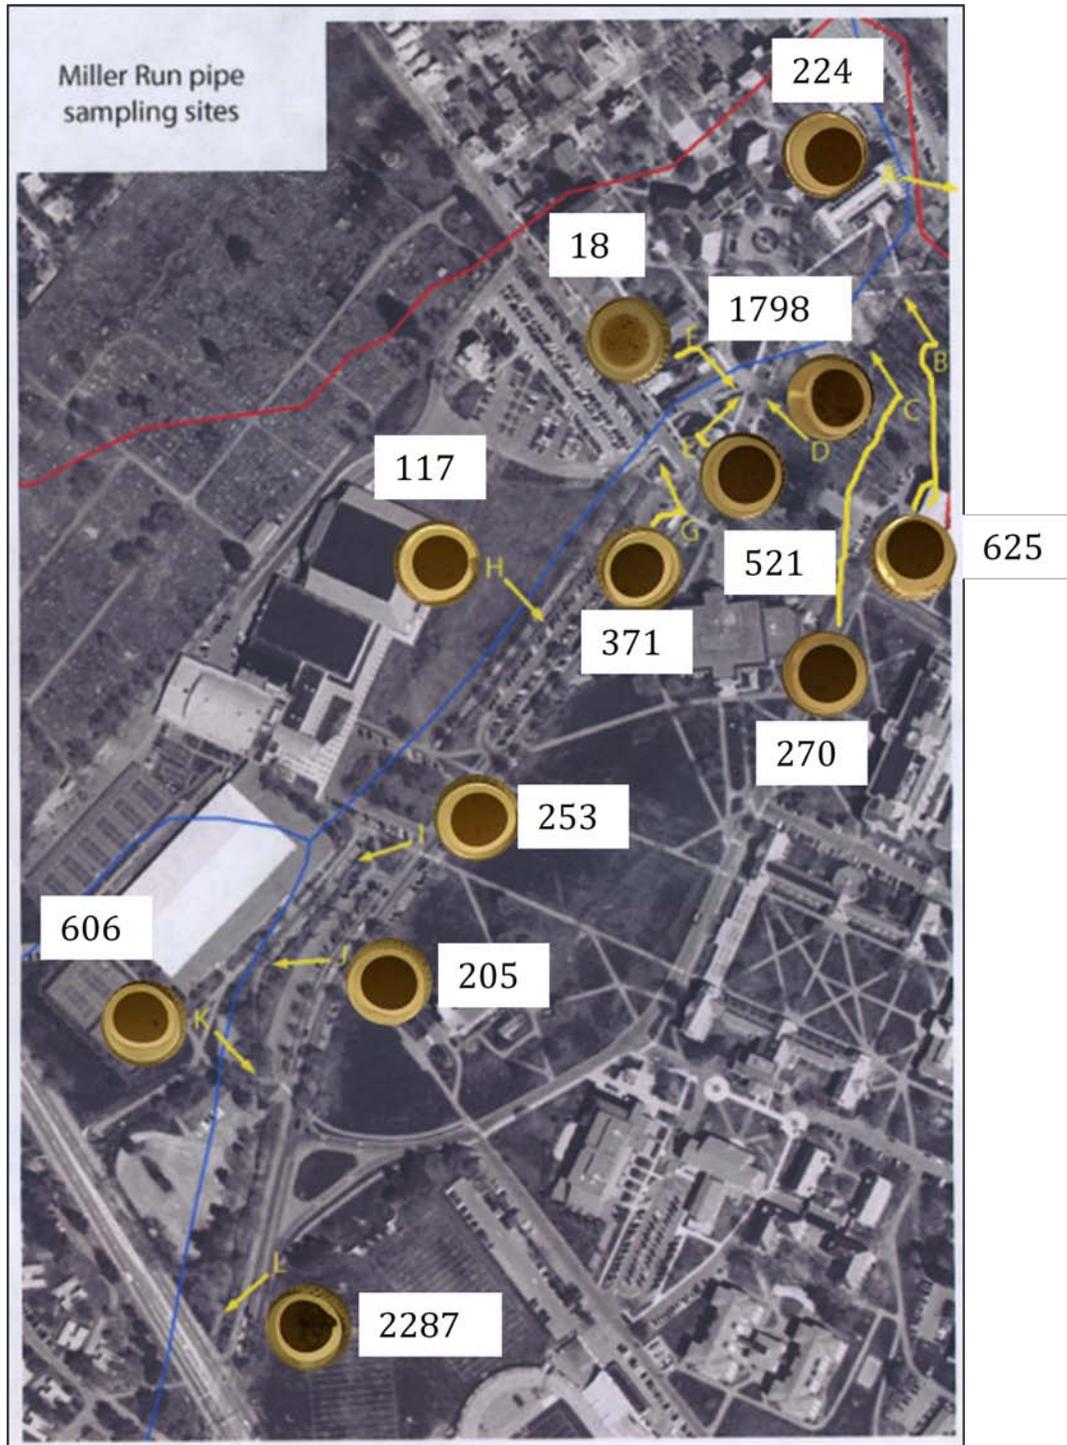
**Figure 2-19.** Sediment Contributions from Various Drainage Pipes, April-3 Event. Numbers show sediment concentrations in ppm.

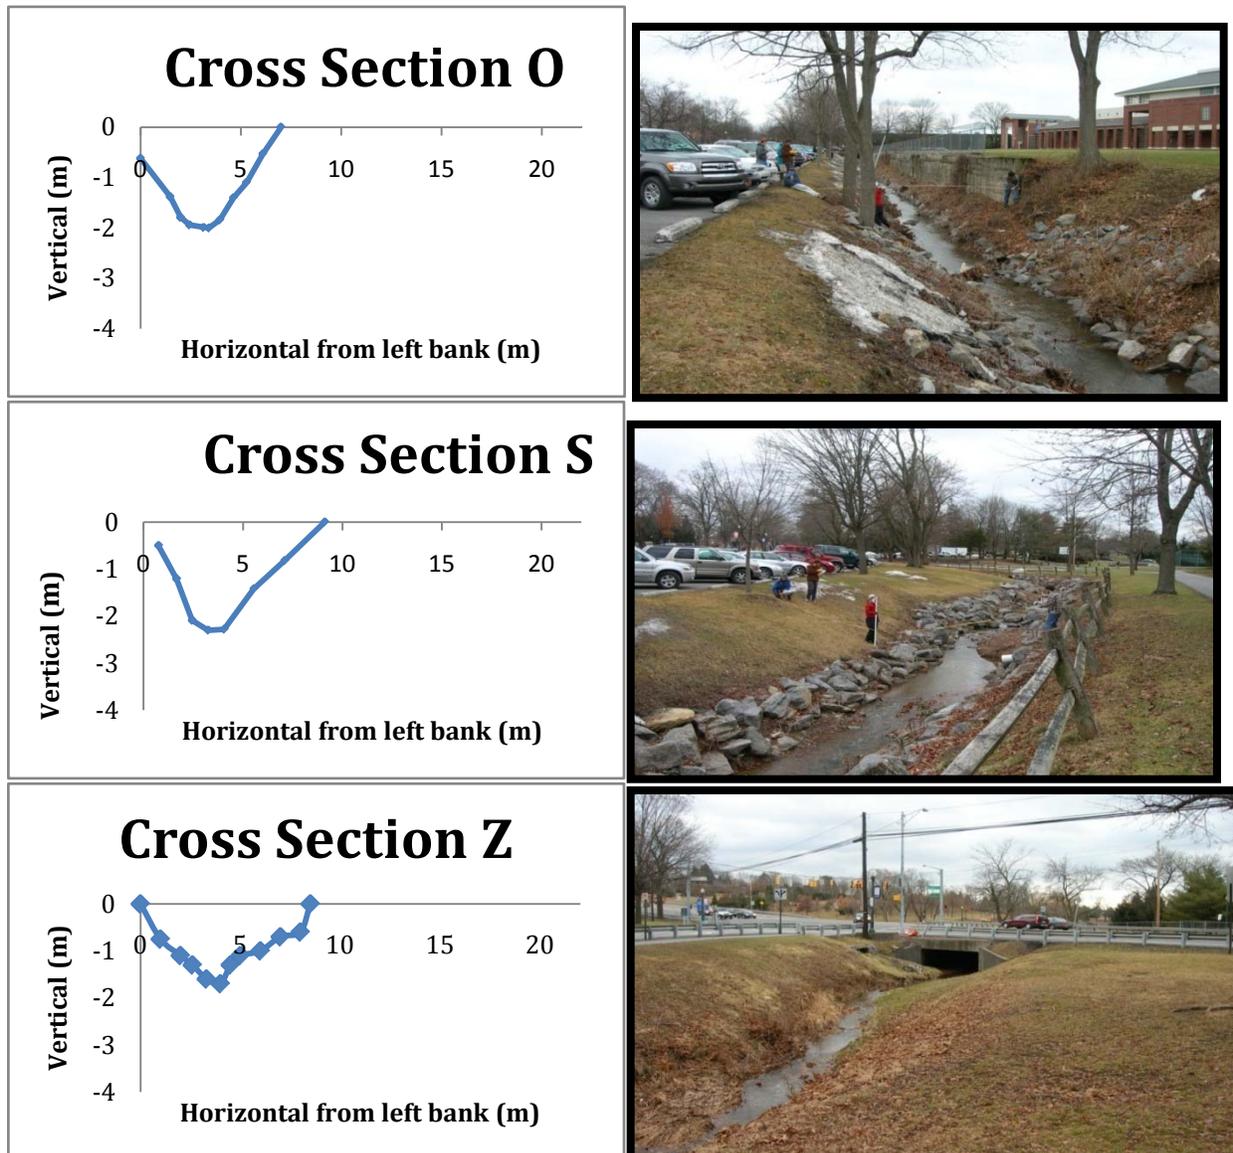
Figure 2-27 Reach 2

Reach 2 then spans from Cross section N-Z which follows in front of the athletic buildings and is very channelized. Cross section O and P follow a pattern deep pools and steep banks due to the cement wall on the left side. Upstream, the cross sections up R-T follow the same general pattern on steep banks. Cross section Y and Z, before Route 15, both have steeper banks with narrow deep bottoms.

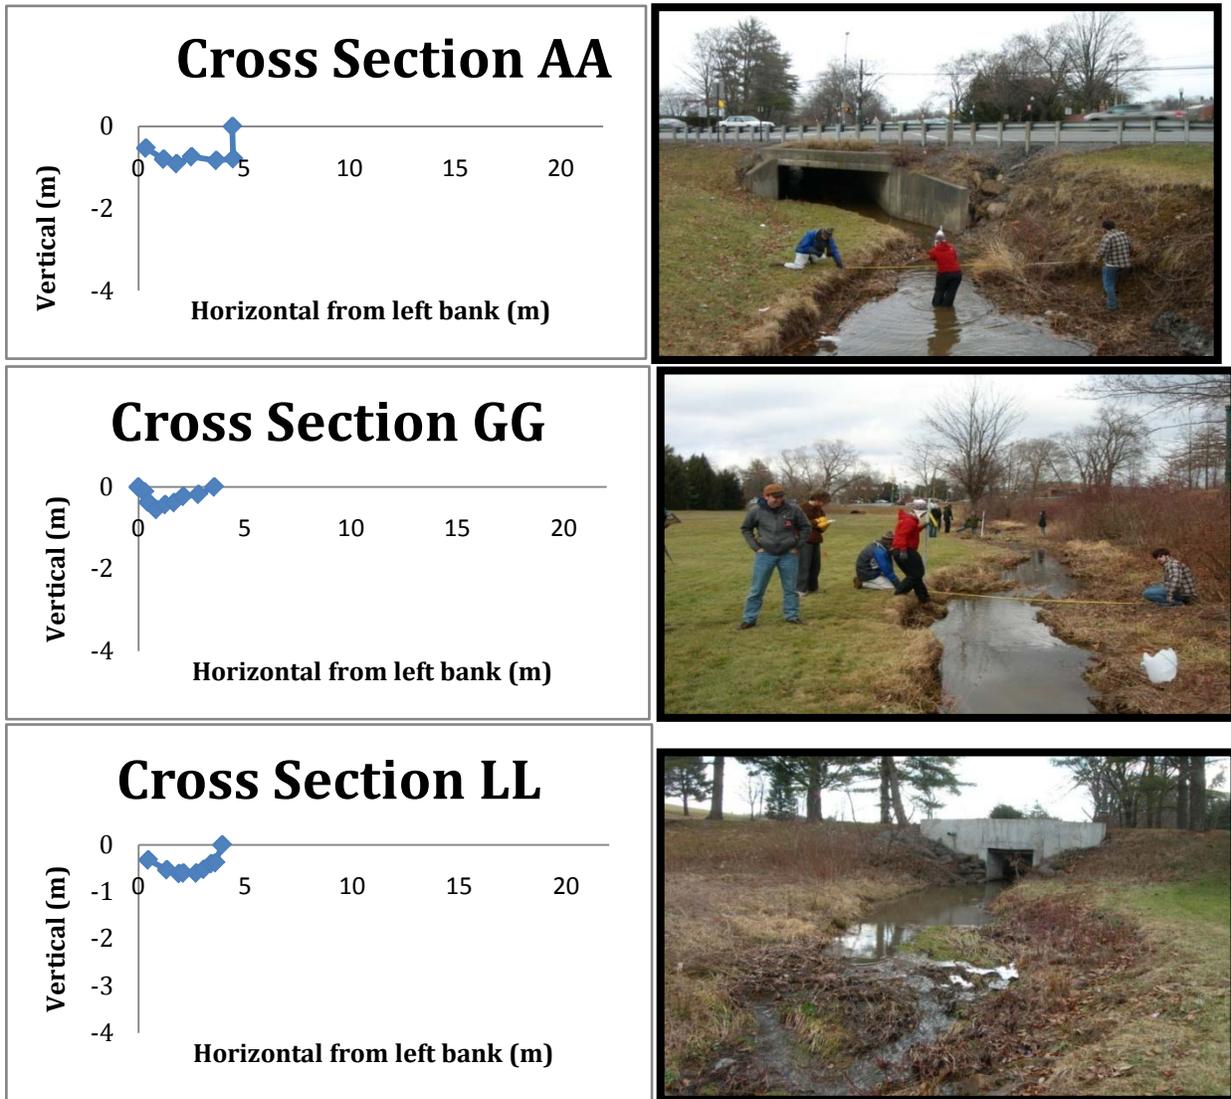
Figure 2-28 Reach 3

At Reach 3, starting after Route 15, the area is wide open with Smoketown Road near the right bank. Cross section AA is shallow with a steep bank on the right side due to the road. The horizontal measurement is very low throughout this reach. All of the cross sections only go to -0.5m vertically in this reach and the banks start to decrease in slope by cross section KK.

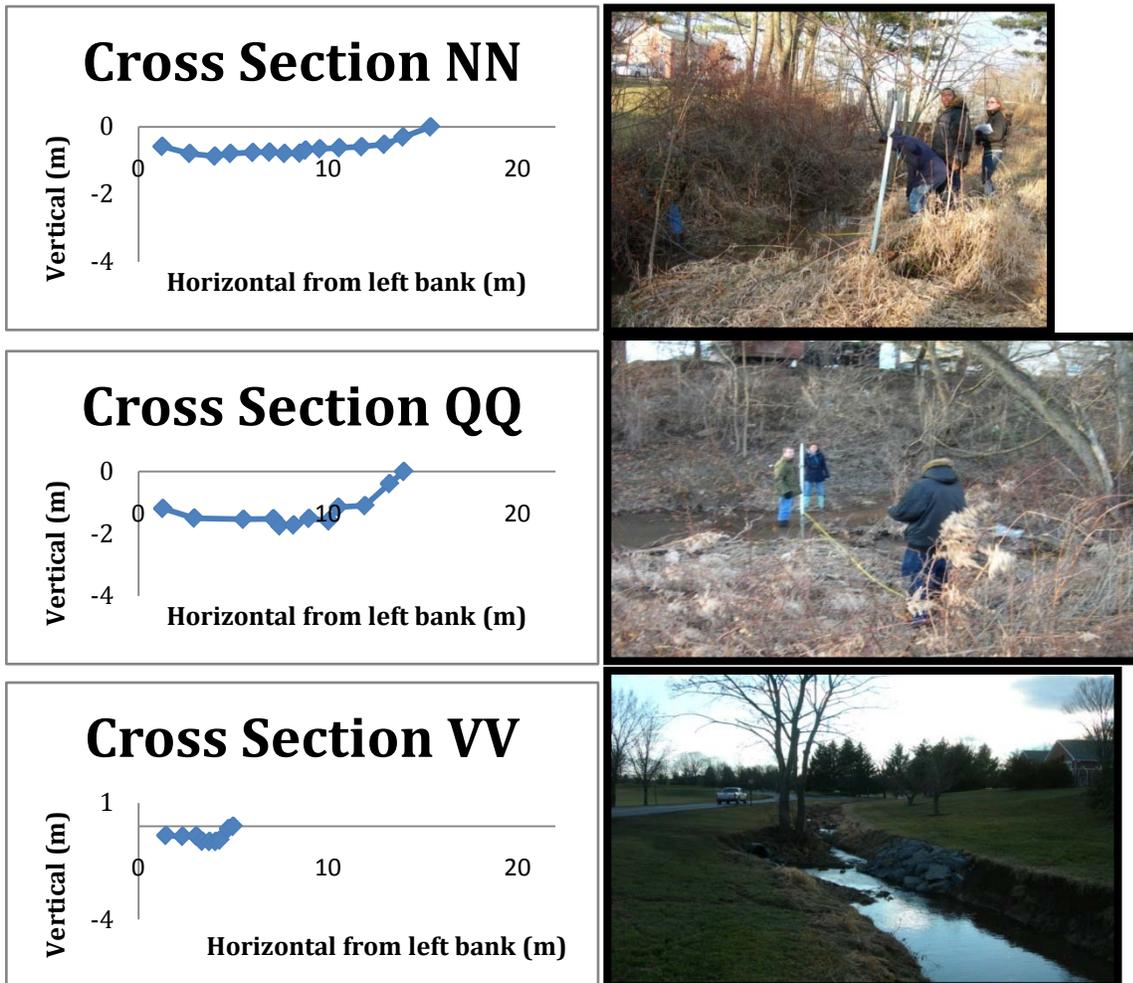
Figure 2-29 Reach 4

At Reach 4, near the Art Barn and coming into the most untouched part of the stream, the cross sections start at MM, but at Cross section NN the stream hits a flat area where the difference in vertical measurement is only -0.5 from bank to bank. Cross section QQ follows a similar pattern to Reach 1 cross sections by having gradual slopes on the left bank and a steeper slope on the right side. The bottom is very flat and is maintained. Cross section UU is deeper while Cross section VV has a very gradual slope on the left side then a steep slope on the right bank.

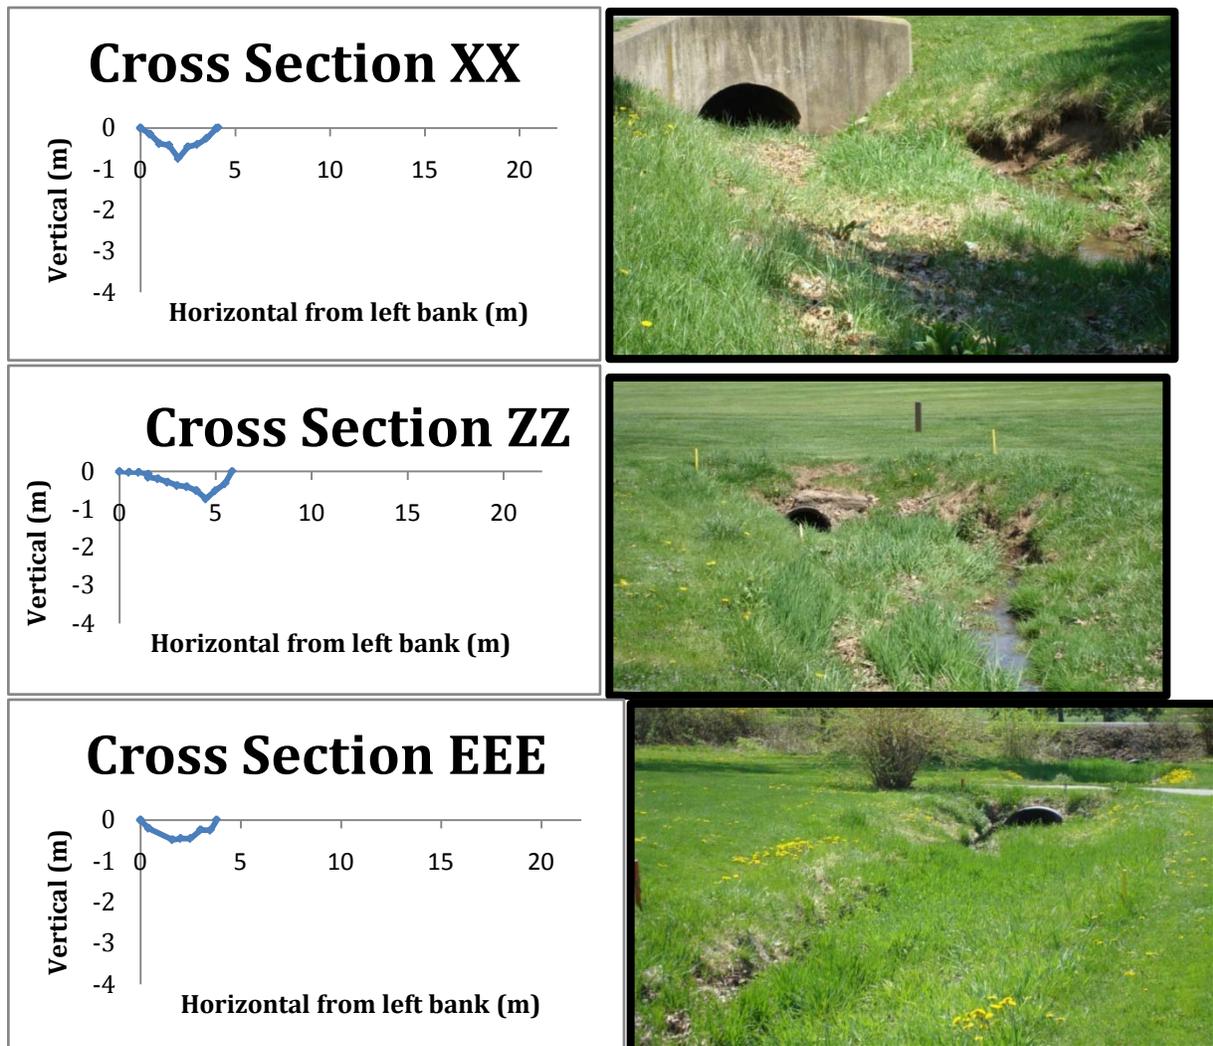
Figure 2-30 Reach 5

Reach 5, which runs throughout the golf course has cross sections that follow the same pattern of gradual steep slopes with narrow shallow bottoms. Cross sections AAA - DDD especially show the small widths and shallow bottoms clearly. The majority of the stream is run through a series of corrugated metal pipes, under fairways. The last cross section in this reach, Cross section EEE, shows the pool that occurs right after the culvert under Smoketown Road.

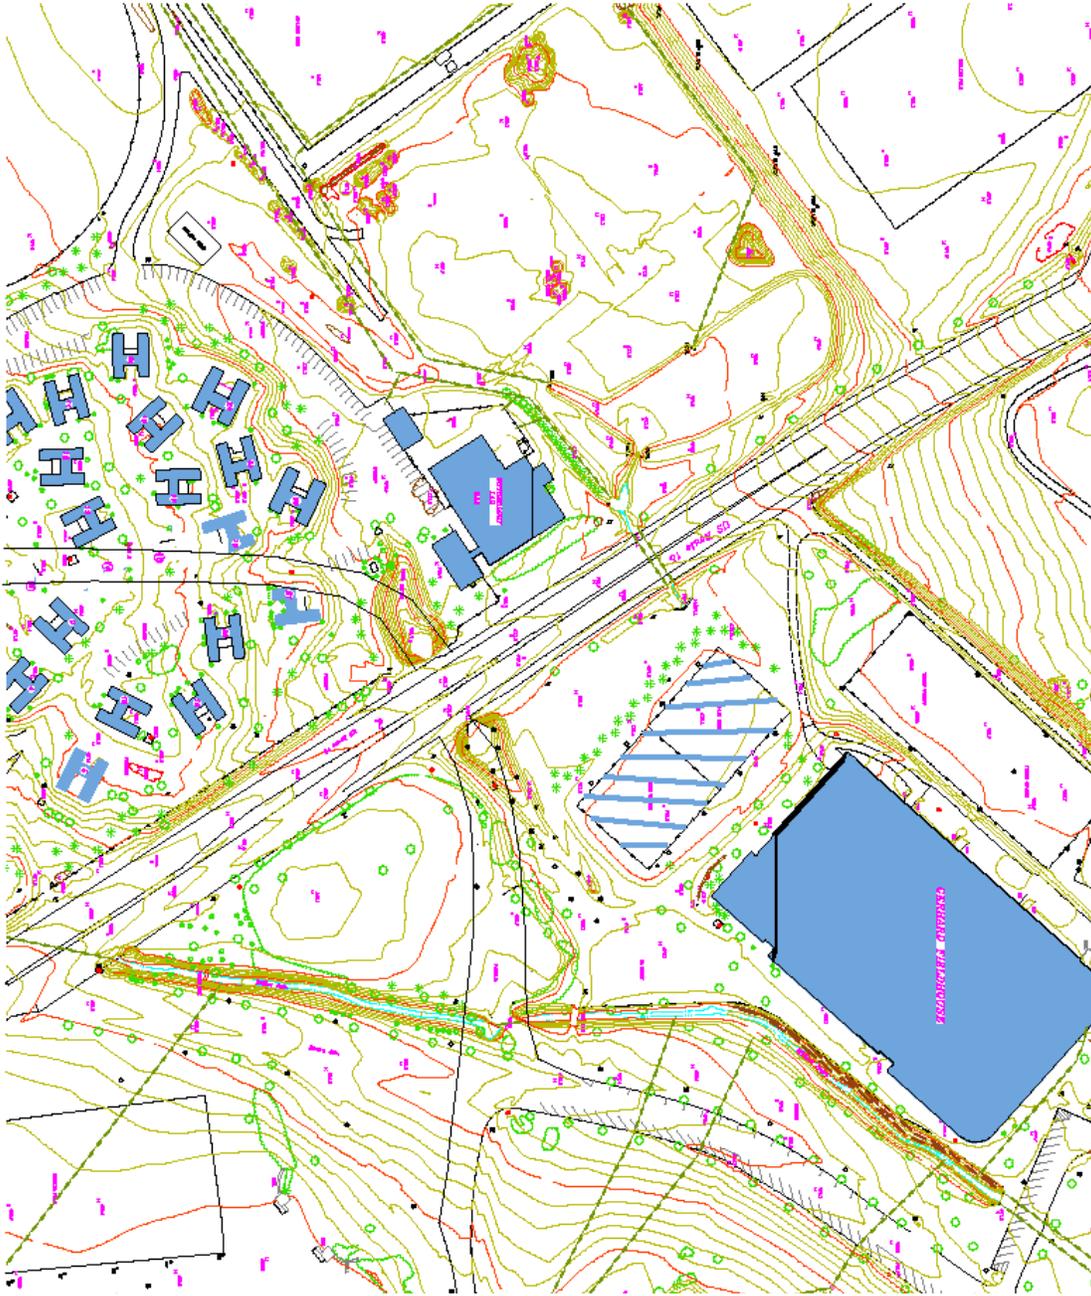
**Figure 3-10** Reach 2b showing proposed realignment of the junction of Moore Avenue and Route 15 (black lines) and proposed log cribbing along the Gerhard Fieldhouse (brown).

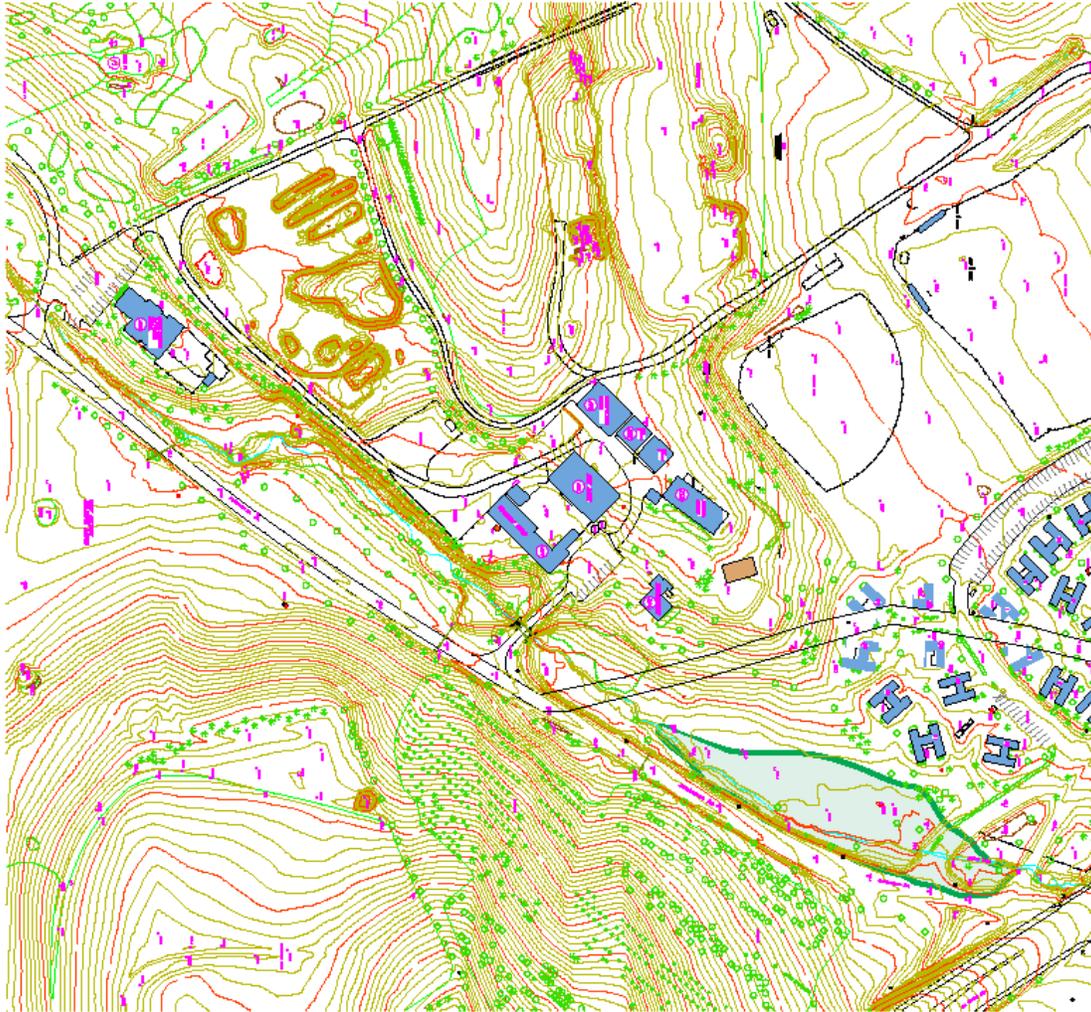
**Figure 3-11** Reaches 3 and 4 from Route 15 (lower right) to Golf Course entrance road (upper left). Note the extensive green ellipse upstream of Route 15, proposed as a major wetland for stormwater retention and low-flow augmentation.

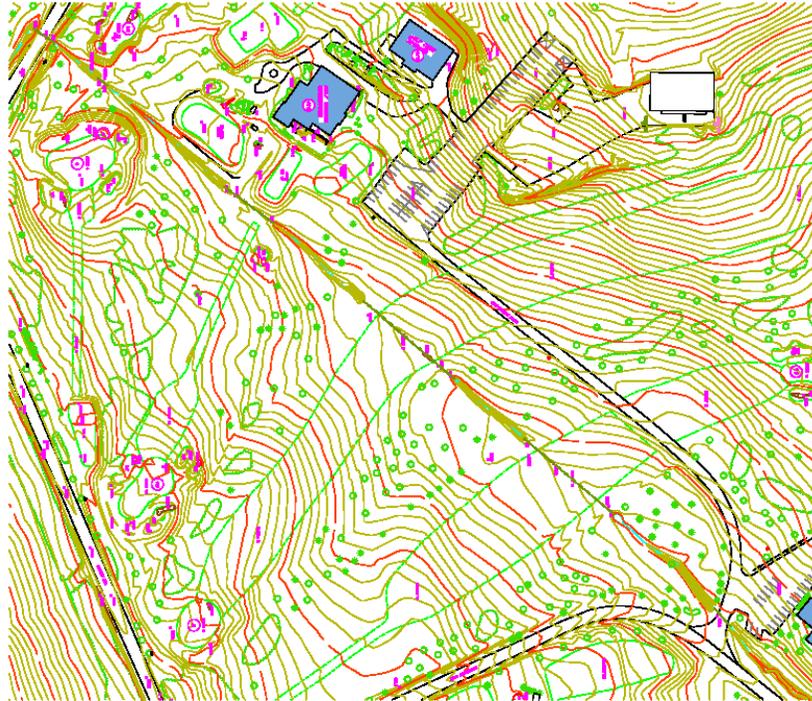
**Figure 3-13** Map of Reach 5, from Golf Course entrance road (lower right) to Smoketown Road (upper left), showing the channelized stream through the golf course.

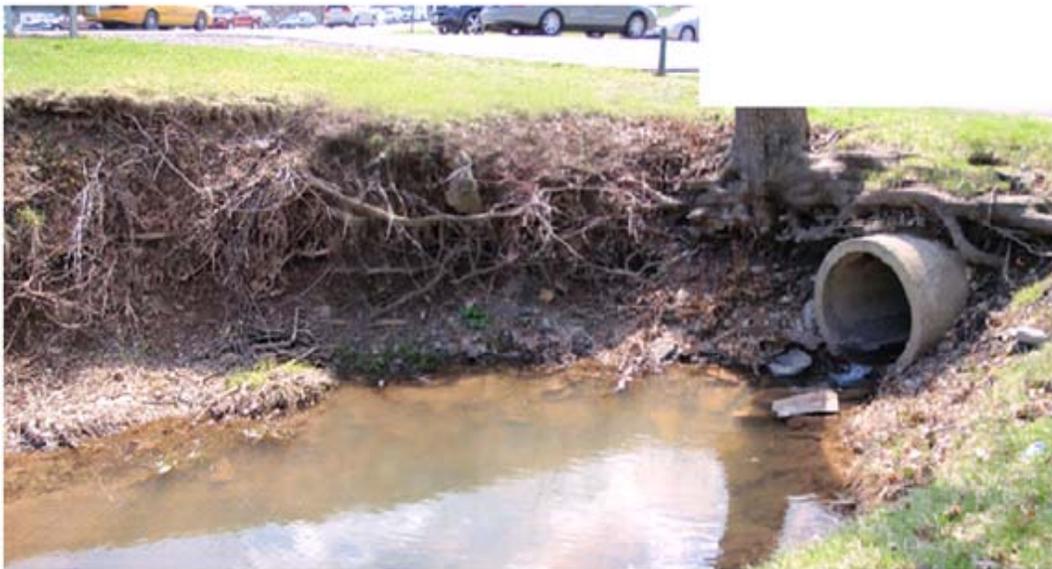
**Figure 3-15** Erosion of Miller Run stream banks on the west side of Route 15
