# Characterization of Miller Run and Conceptual Plan for Watershed Restoration

Final Report for a Class Research Project

UNIV 298/GEOL 298/BIOL 298/ENST 298  
Stream Restoration -- Spring 2009

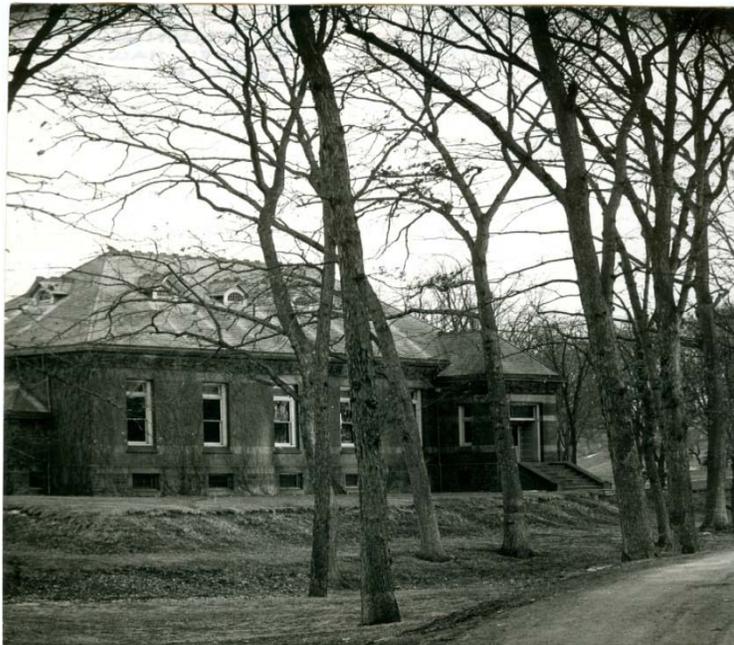
**Figure 2-66 Bucknell Hall 1930s**

This is a picture of Miller Run in the downstream area next to Bucknell Hall. This photograph shows that the channel and floodplain have already been terraced and channelized to elevate the building above the floodplain.

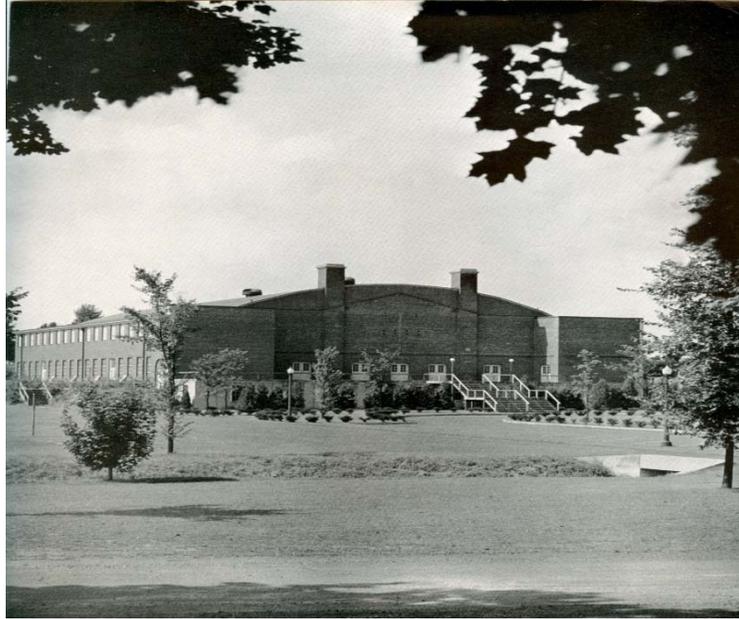
**Figure 2-67 Davis Gymnasium 1940s**

This print is of Miller Run in front of the old Davis Gymnasium. This is a part of Miller Run where the data for Reach #2 was collected. In the 1940's it is evident that there was yet to be the placement of rip rap in Miller Run. It is evident that Miller Run has already been straightened and channelized.

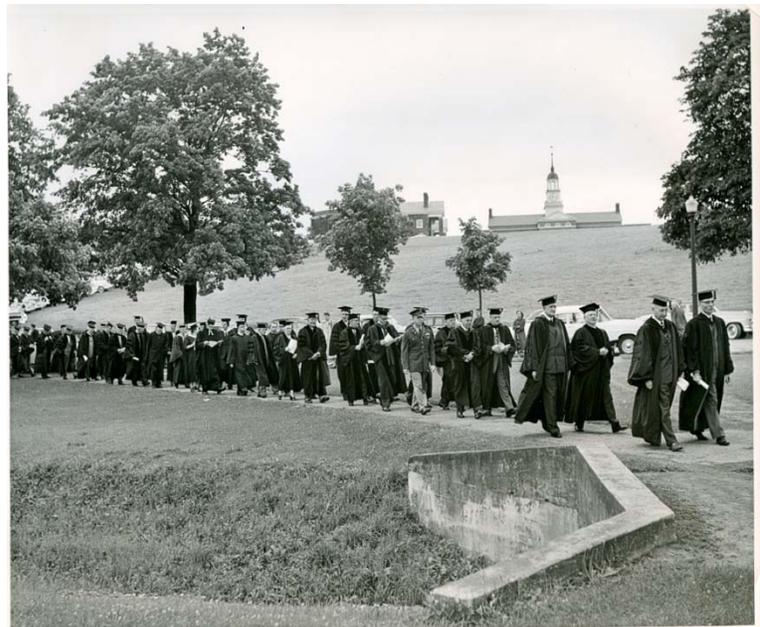
**Figure 2-68 Bucknell Commencement 1950s**

This graduation photo from the 50's shows the existence of numerous culverts and channelization.

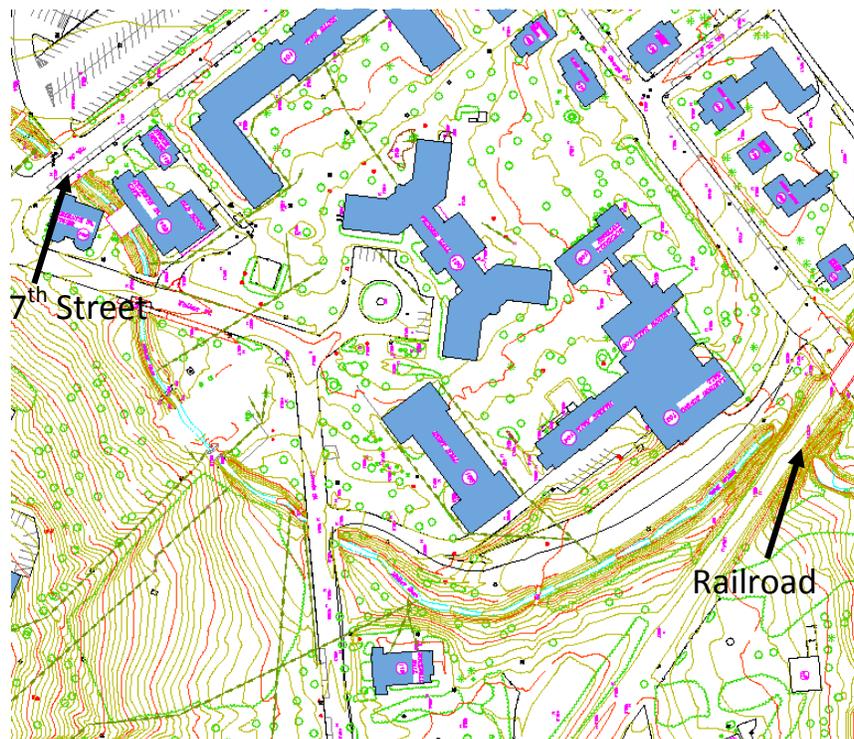
**Figure 3-7** Reach 1 with Art Building removed (blank rectangle).

Reach 1 is the area that runs from the railroad bridge crossing up to where Miller Run meets 7<sup>th</sup> Street (Figure 3-7). The most prominent problem in this area is that the stream must make  $\sim 90^\circ$  turn the stream to enter the culvert. The culvert is small (< 2 year flood) and cannot allow for much water to pass through it during high flow events (Figure 3-8). The best possible solution would be to remove the railroad bridge all together. However, this is highly unlikely so the widening of the already existing culvert or the addition of another culvert could solve the problem. The culverts should have the capability to convey a 100-year flood, similar to the culvert at the stream's intersection with Route 15 (Figure 3-8). A widened or added culvert of this capacity could prevent flooding of Hunt parking lot, as water could move swiftly out of the area. The removal of the Hunt/Harris Hall parking lots, in general, would also help this problem and aid in floodplain-stream reconnection. This would allow the stream to have a more natural floodplain, connecting it to the upland Grove with a blended transition, and permit water storage during flooding.

For more aesthetic appeal as well as encouragement of riparian growth most of the rip-rap in this reach also needs to be removed, except on the banks nearest to the intersection of Loomis Street and Miller Run culvert (~10 feet on both banks and both sides of the culvert). Other obstructions that should be removed include the Art Building (already destined to disappear according to the Campus Master Plan). This section between the Art Building and Loomis Street includes a gravel plot, rip-rap, and footbridge as well. If possible, relocating the footbridge to where the pipes cross the stream would prove to be more aesthetically pleasing. The longitudinal profile of the reach shows a very low grade, especially at this point, and flow oftentimes stops right underneath the Art Building. The area currently occupied by the Art Building would make for a great scenic, park-like area. Vegetation and park benches would be a great addition. The culvert at the intersection of Walker Street and Miller Run is necessary, but may have to be rebuilt to contain more than just the current <5 year storm event (Figure 3-8). Unfortunately for the stream, 7<sup>th</sup> Street Café and the 7<sup>th</sup> Street House are not going to move. Therefore, the stream must be channelized here to prevent undercutting of the structures. We suggest leaving the current rip-rap in place but adding more riparian vegetation between the boulders for a more aesthetic approach. Alternatively rip rap could be replaced with more aesthetic log cribbing.

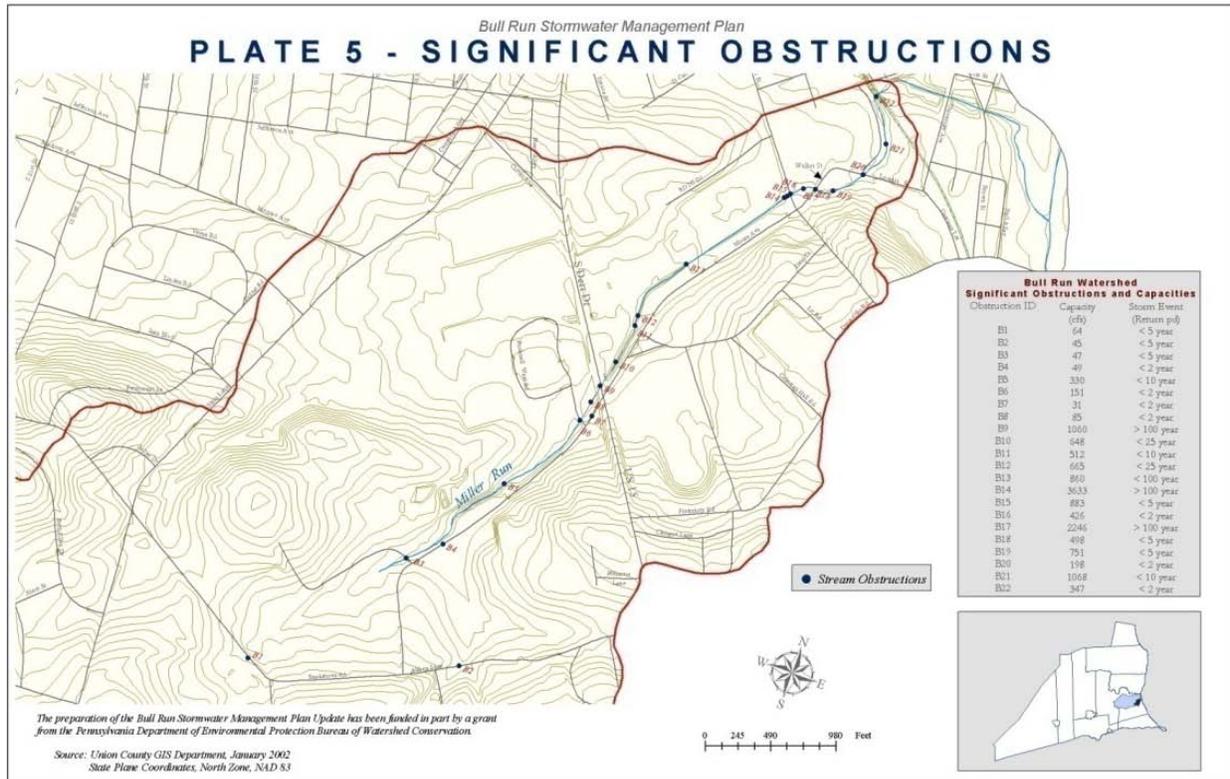
**Figure 3-8** Bull Run stormwater management plan, showing obstructions along Miller Run and the conveyances for each (Union County Planning Commission, GIS Department 2002).

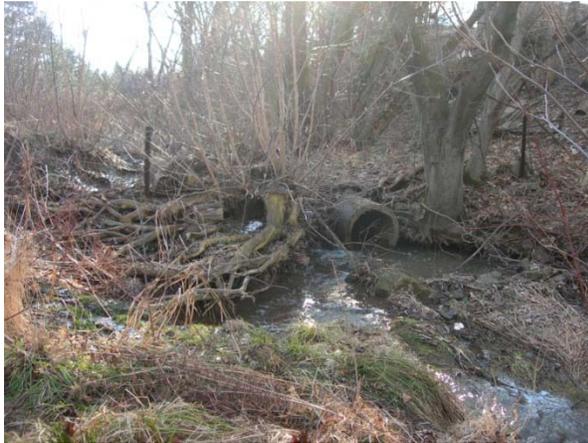
Reach 4 consists of the area of Miller Run that runs from the Art Barn Bridge to the Sunflower Daycare Center (Figure 3-11). This is currently the most recently untouched part of the stream. But it is one of the most disturbed areas because it contains the fill from a former coal handling operation, its clay cap, and old culverts – creating a major knickpoint in the longitudinal profile and a problem spot for fish migration (Figure 2-25, 3-12). The fill has induced a zone of enhanced sedimentation which is now colonized by dense invasive vegetation – albeit woody. Another problem spot in Reach 4 is the junction with Miller Run’s south branch, storm-piped in from under the driving range. The angle at which south branch comes in encourages bank erosion on the left bank of Miller Run. Currently there is rip-rap trying to prevent the wear down of the bank, however a more aesthetically pleasing and habitat-supporting method of bank stabilization could be log-cribbing. The dimensions of the

**Figure 3-12** Knickpoint at downstream edge of the fill covering coal handling deposits.

structures themselves would be small, no more than 10 feet in width across. If log-cribbing is not a viable option for the small area, highly vegetated rip-rap may be used instead.

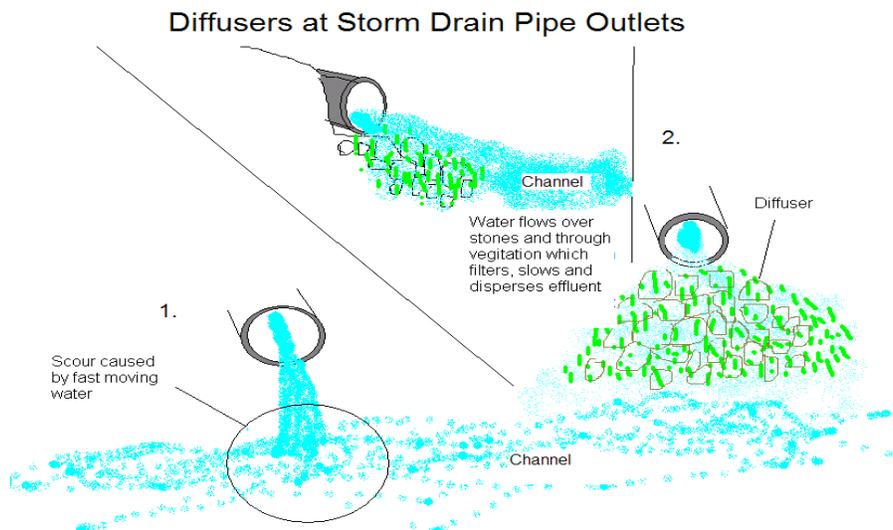
One problem associated with storm water flushing through drainage pipes is the high velocity and power with which this water enters Miller Run. Often, drainage pipes are elevated above the active channel to avoid backing up when stream stage increases. However, high velocity water creates severe channel instability at the outlets of storm drains (Figure 3-14). Some of the largest pools in Miller Run are scour pools at the mouths of storm drains (near the Gerhard Fieldhouse, for example). Diffusers could be installed at the ends of storm drain pipes to slow and filter runoff before it enters the stream. Some of the designs which look the most promising consisted of vegetated riprap fans (Figure 3-14). These types of diffusers eliminate scour, which causes erosion. Redesign of the channel of Miller Run would create the opportune moment for diffusers to be created out of excavated rip rap that might otherwise be discarded.

**Figure 3-14** Depiction of pipe scour (1.), the problem that diffusers attempt to rectify and a theoretical design of a vegetated storm water pipe diffuser shown from the front and side (2.)
