Characterization of Miller Run and Conceptual Plan for Watershed Restoration

UNIV 298
Spring 2009

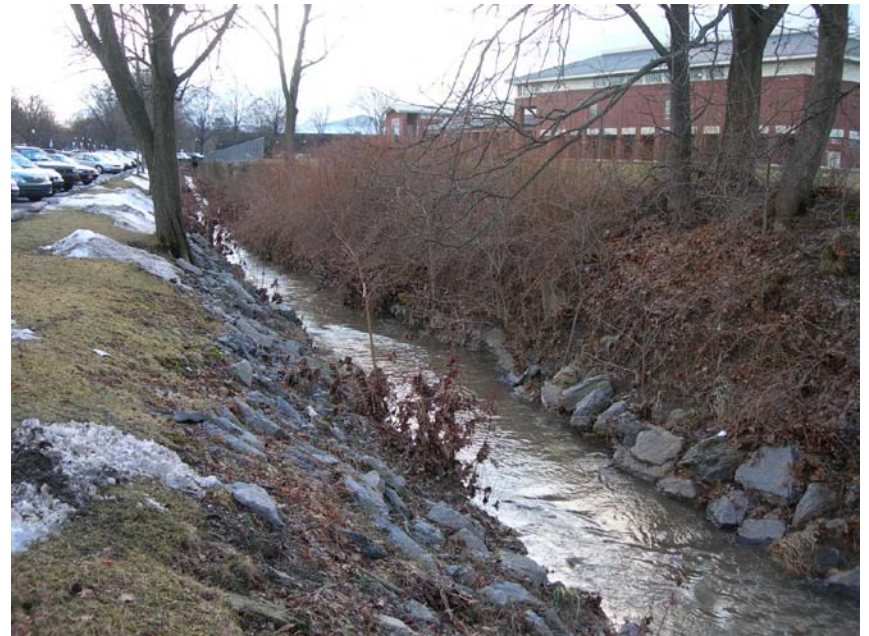
Miller Run Statistics

- 80% of Miller Run is owned by Bucknell.
- The runoff from the new housing developments also contribute to the stream.
- Length of Stream: 2,000m
- Percent Forest: 13.1% (The Grove and the Golf Course)
- Percent Urban: 37.5% (Buildings and Roads)
- **Channelized: 75-100%**
- **50% Rip-rap**

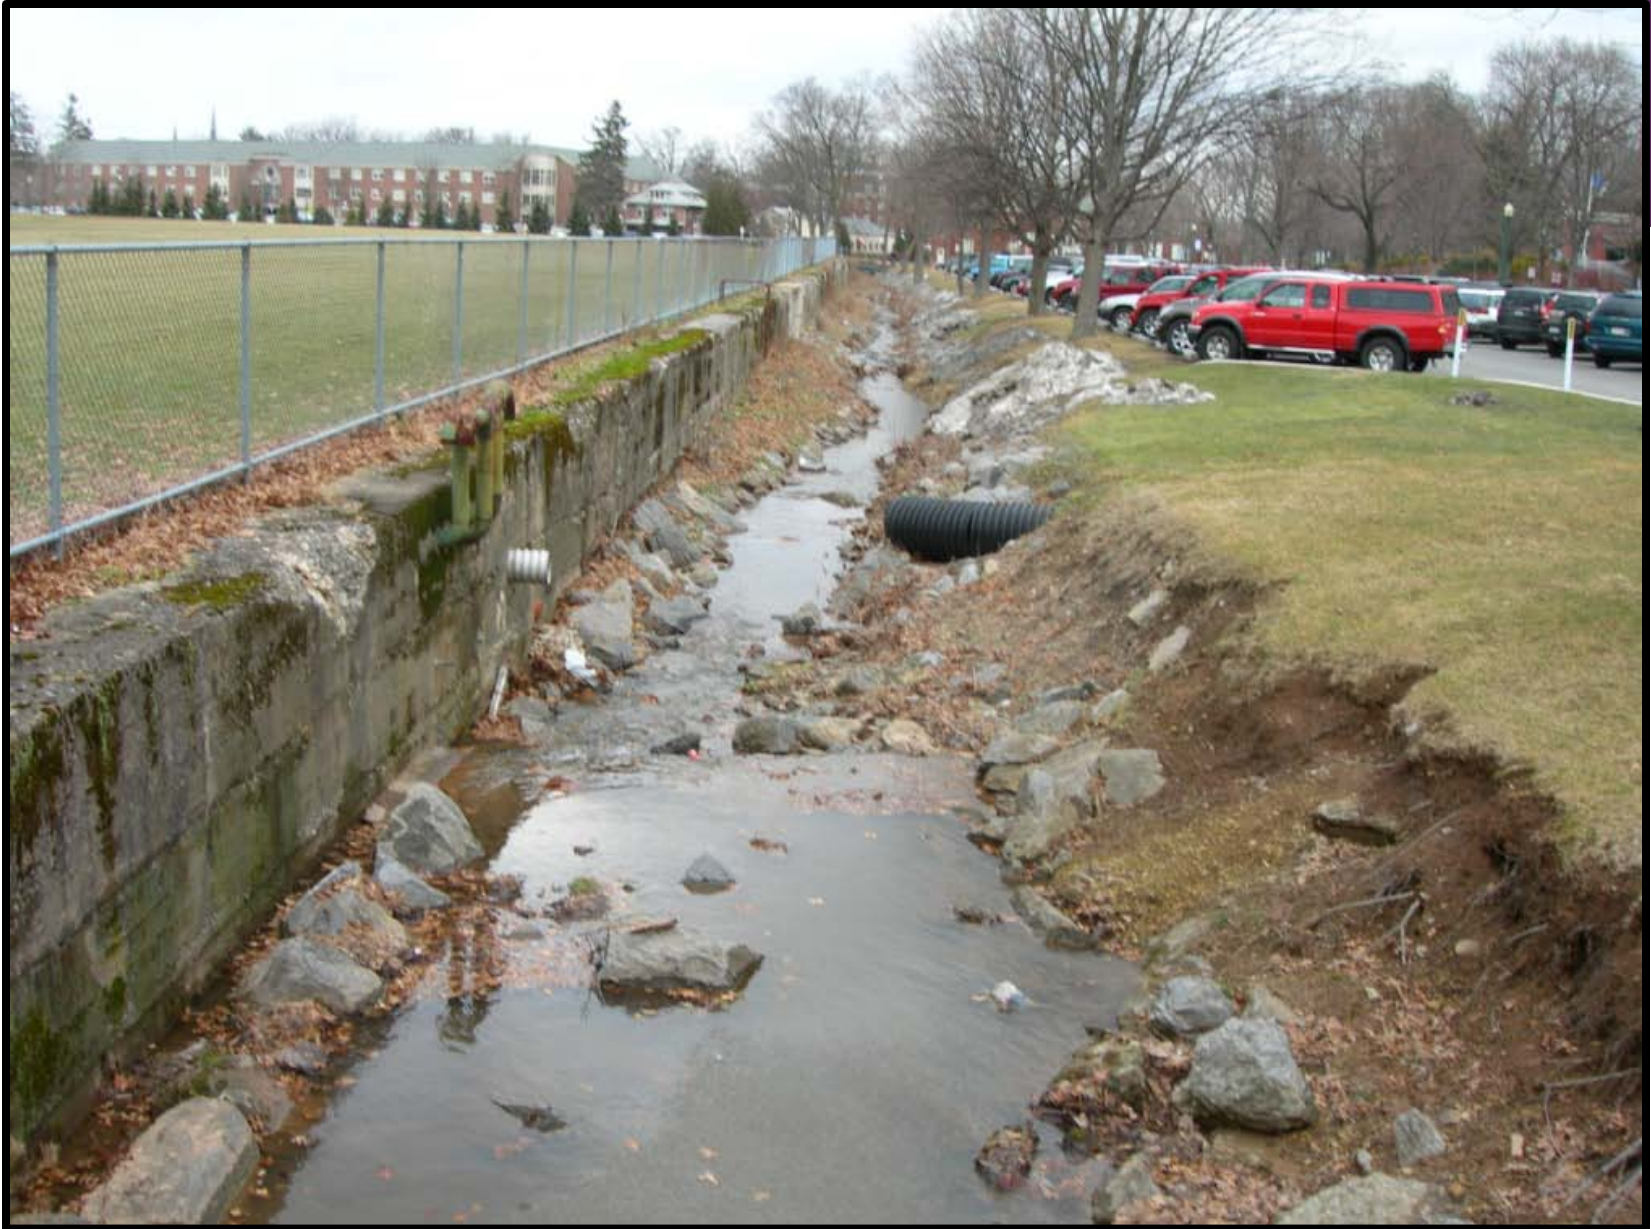
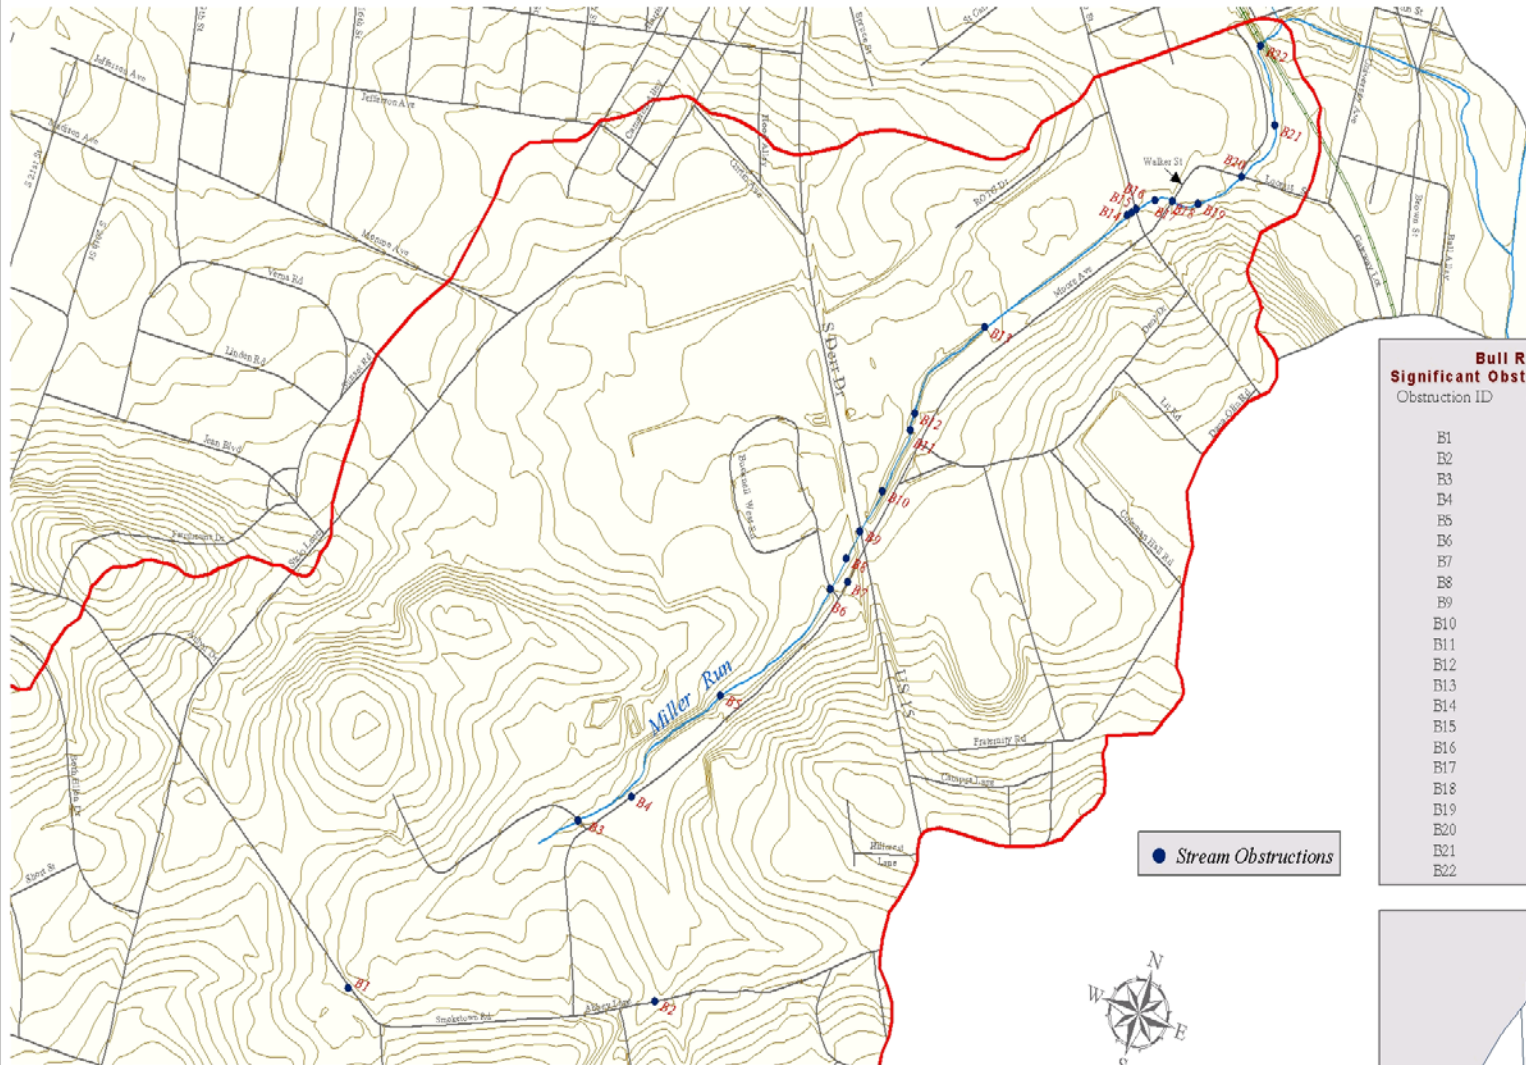
PLATE 5 - SIGNIFICANT OBSTRUCTIONS

**Bull Run Watershed
Significant Obstructions and Capacities**

Obstruction ID	Capacity (cfs)	Storm Event (Return pd)
B1	64	< 5 year
B2	45	< 5 year
B3	47	< 5 year
B4	49	< 2 year
B5	330	< 10 year
B6	151	< 2 year
B7	31	< 2 year
B8	85	< 2 year
B9	1060	> 100 year
B10	648	< 25 year
B11	512	< 10 year
B12	665	< 25 year
B13	860	< 100 year
B14	3633	> 100 year
B15	883	< 5 year
B16	426	< 2 year
B17	2246	> 100 year
B18	498	< 5 year
B19	751	< 5 year
B20	198	< 2 year
B21	1068	< 10 year
B22	347	< 2 year

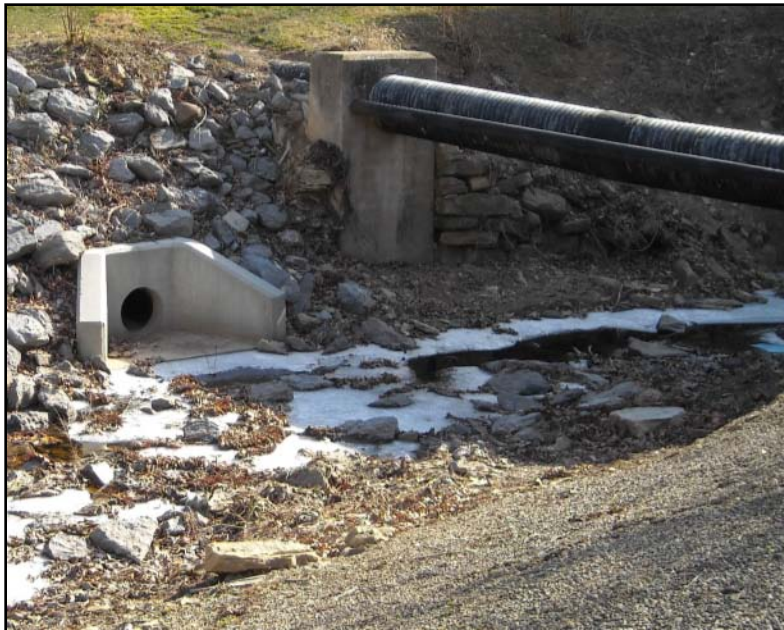
Frequent Periods of Zero Flow

- Portions of Miller Run frequently go dry
- Water quickly enters and exits the system
- High sediment content: hinders life, destroys restoration structures

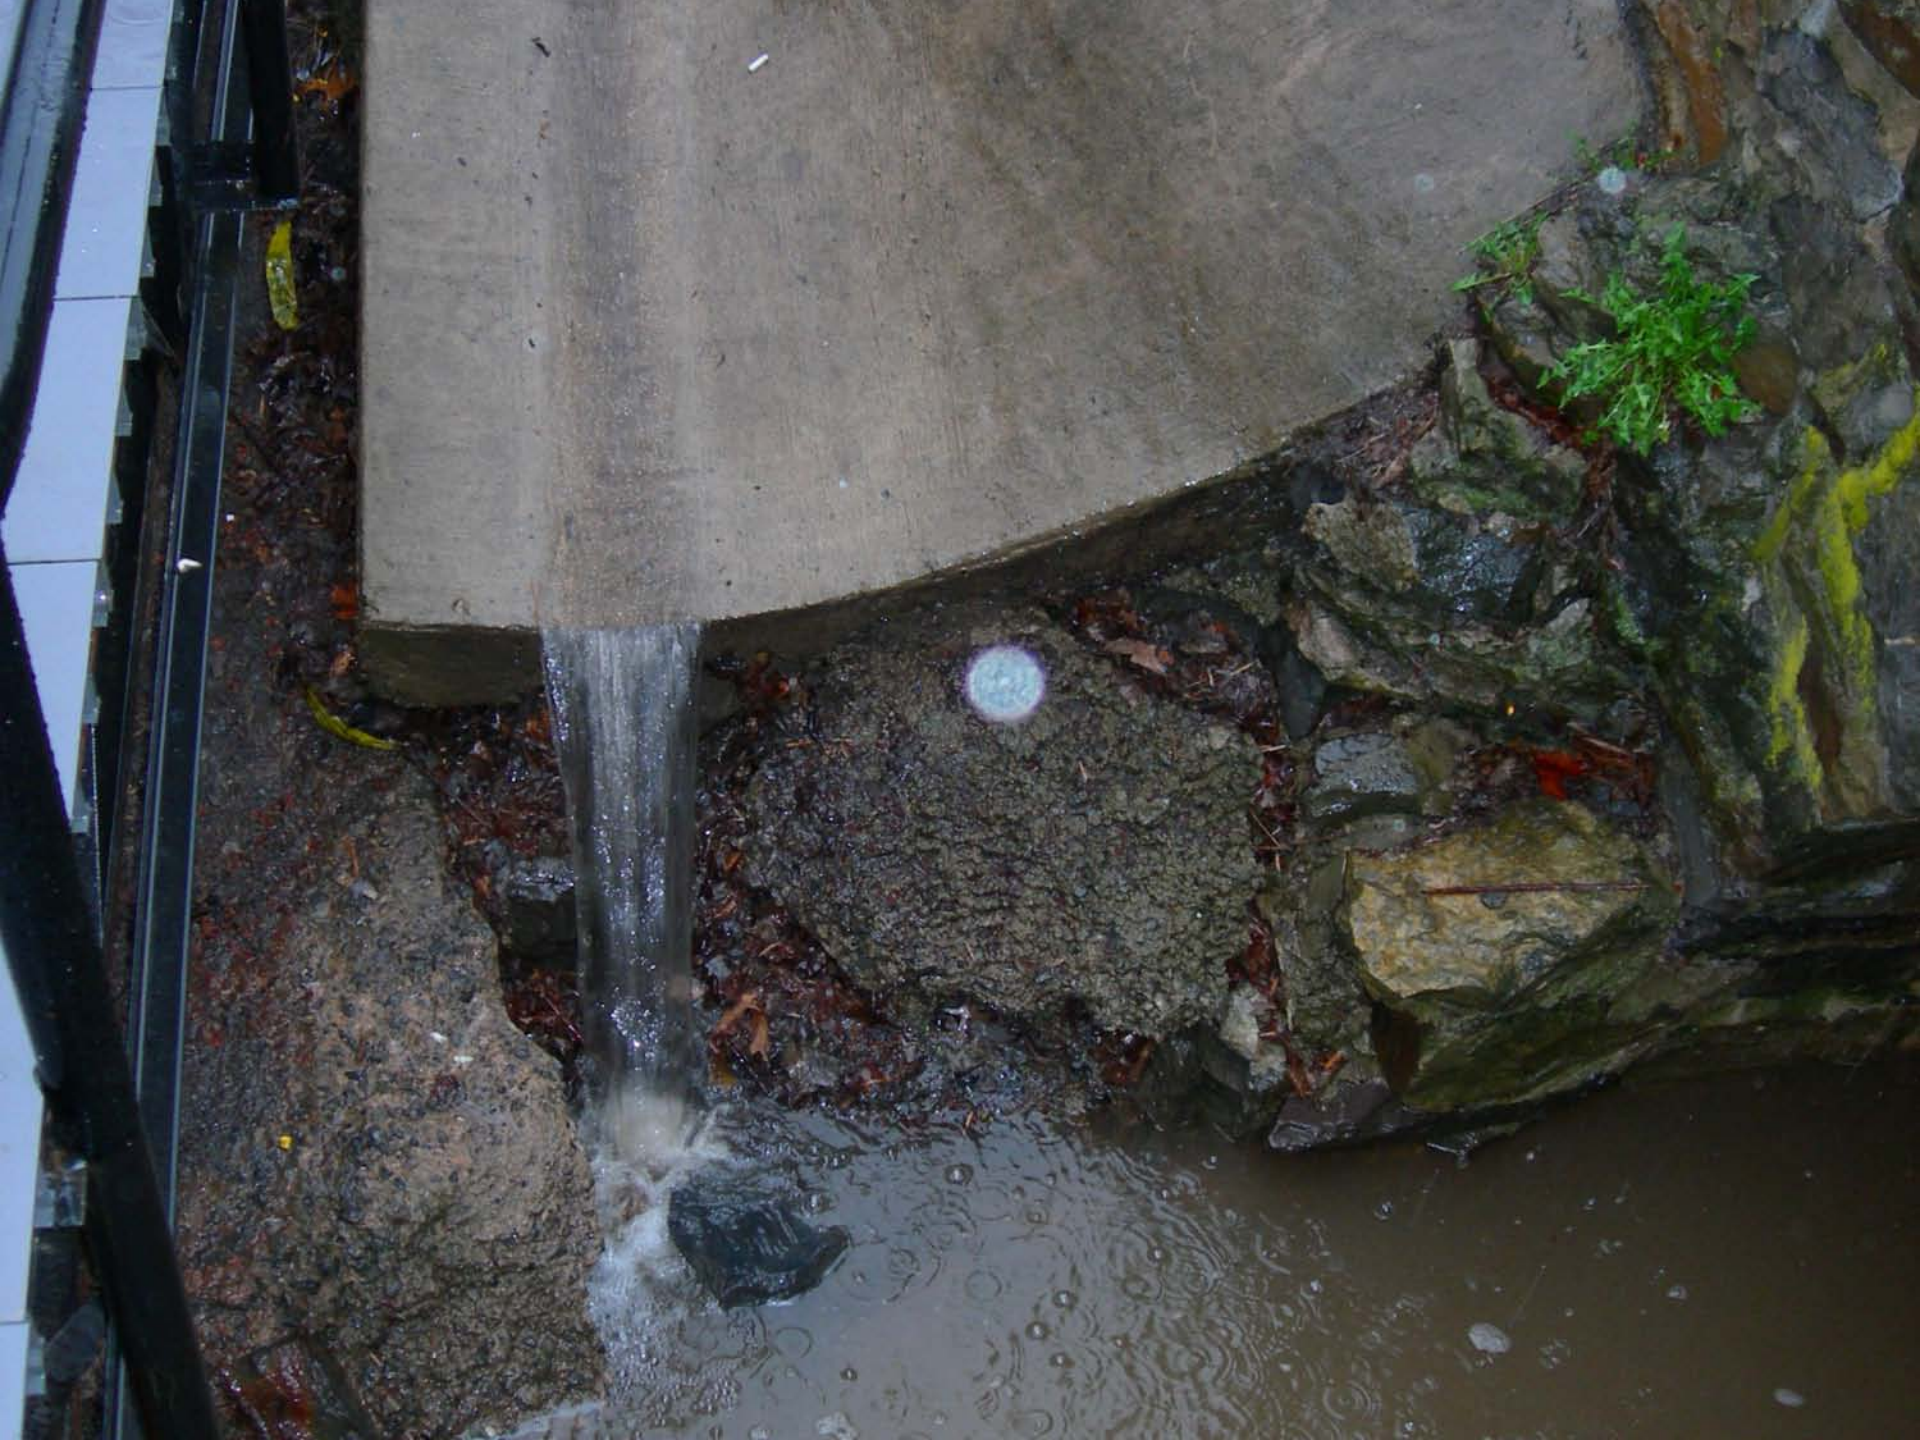
Feb 18 Snowmelt and Rain Event Hydrograph

Storm Pipes
throughout campus
responsible for the
double peak

- Buildings and storm drains feed directly into Miller Run.
- Large amount of storm water produced.
- Explains why downstream peaks before upstream.
- Structures that could help cut down on surplus of water.
 - Porous Pavements
 - Asphalt, concrete, and block pavers
 - Infiltration trenches
 - Rain Gardens

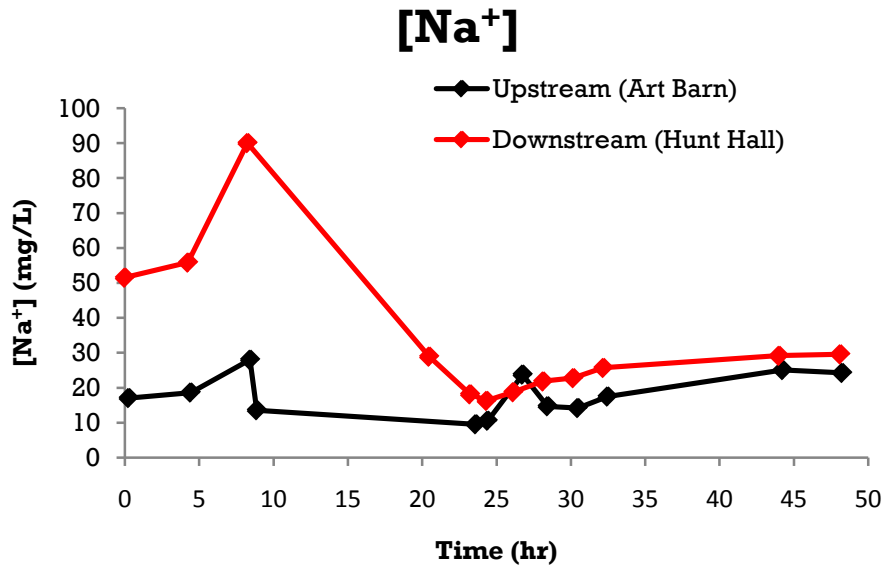
Sodium, Chloride, and Potassium Fluctuations (February 7-9, 2009 Snowmelt)

Negative Impacts: Surface runoff and interflow carry high ion loads into the waterway from road salts and fertilizers.

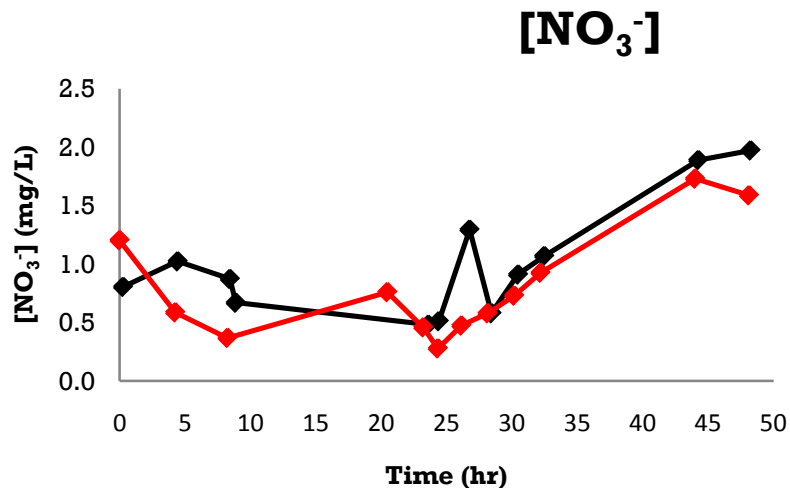
+ Sulfate and Nitrate Fluctuations (February 7-9, 2009 Snowmelt)

- Initial decrease is due to simple dilution.
- Increase is due to an underground contaminant located near the upstream site—probably fertilizer accumulation or a broken sewage line.

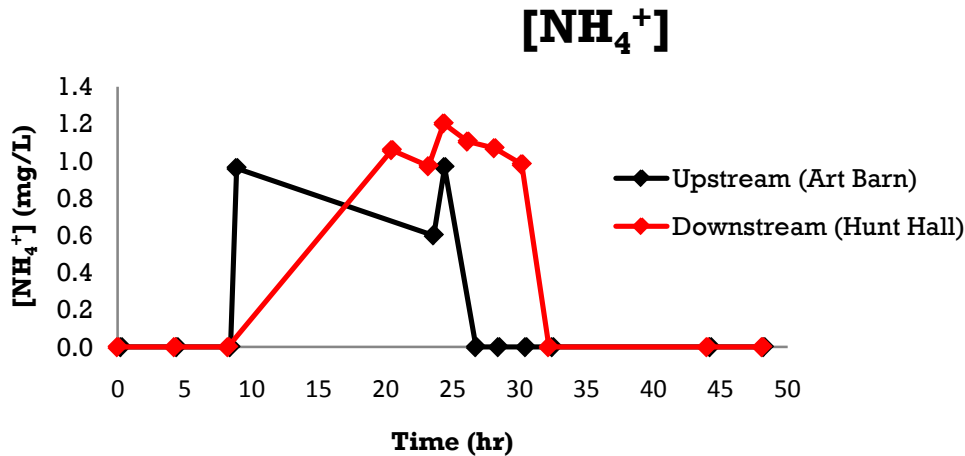
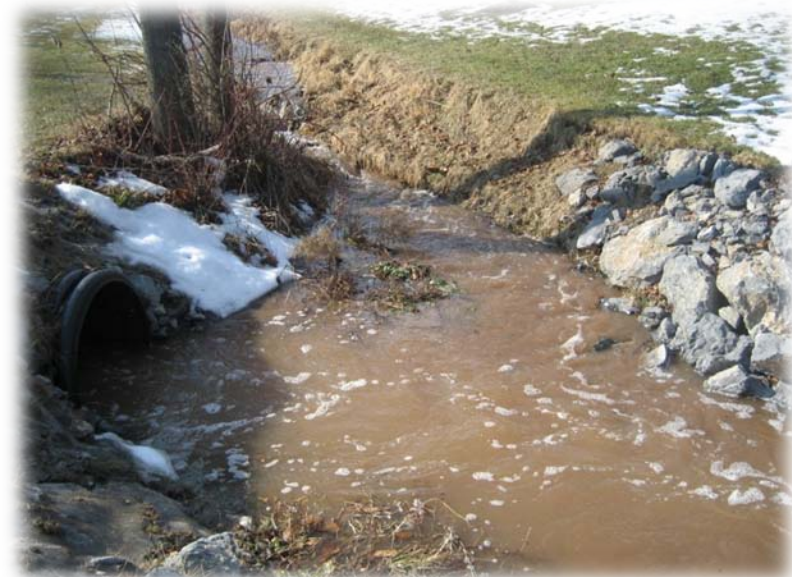
Ammonium and Phosphorous Fluctuation (February 7-9, 2009 Snowmelt)

Delayed peak reveals an underground source of contamination near the upstream site.

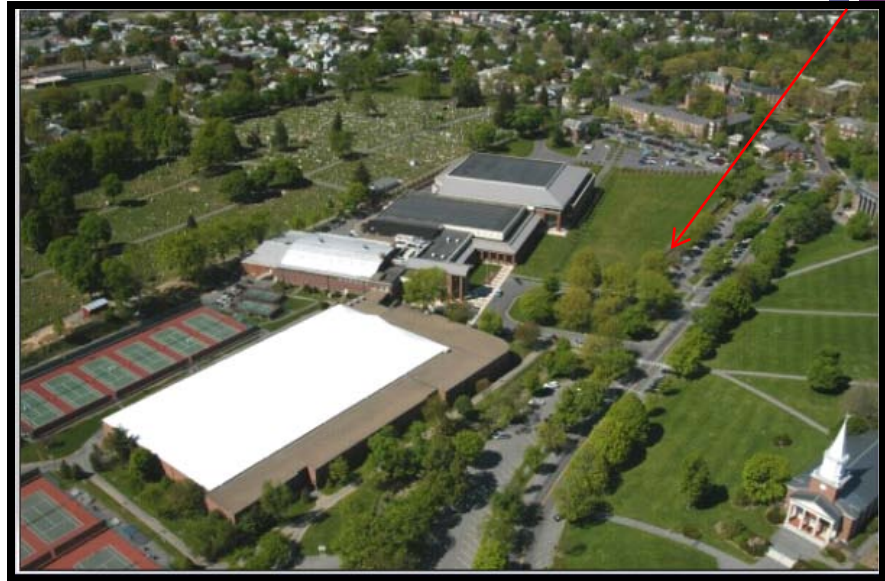
- Two wetland areas
 - Sojka Lawn
 - Mod Field area
- Floodplain reconnection
- Stream corridor/vegetation
 - Biodegradable fabrics
 - Plant natives
